Black Hawk Helicopter Vibration Analysis Due to Main Rotor Damage, Directional Constituents of the Resultant Vibrations

ARL-TR-2442

Survivability/Lethality Analysis Directorate, ARL

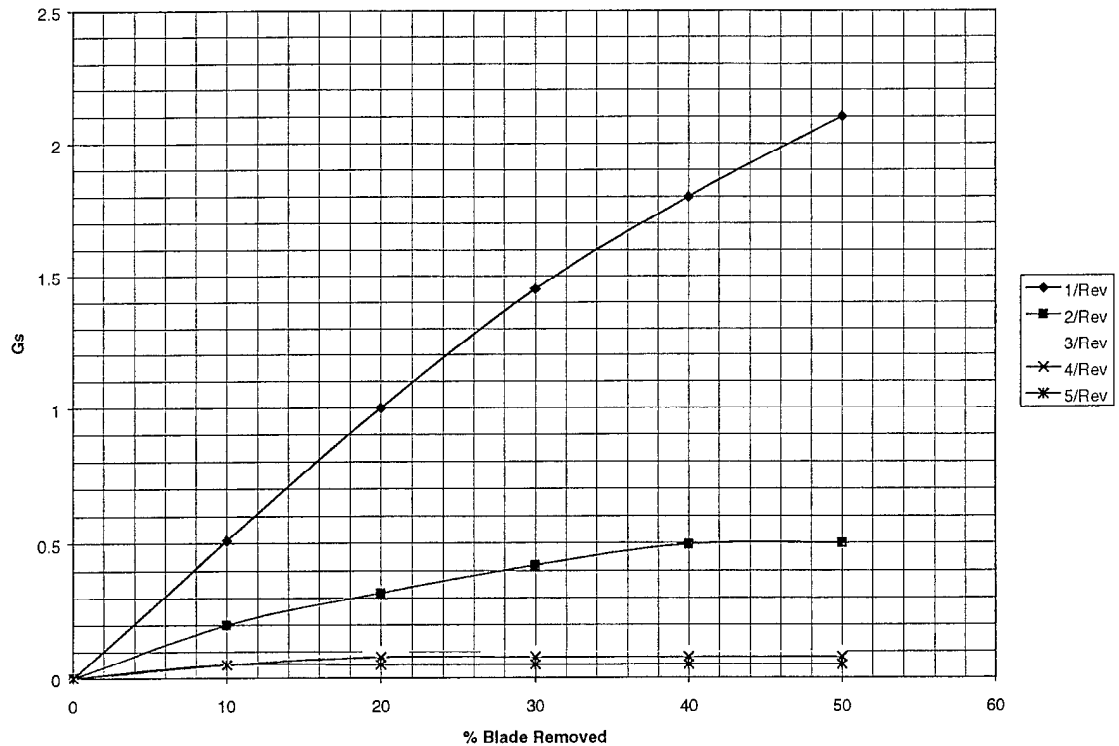
First, the resultant vibrations are shown in Figure 1 as G's (gravitational pull) vs. percent of the removal of the outer blade section.

Figure 1. Cockpit resultant vibrations G's vs. percent of blade removed.

There is a predominate 1/Rev frequency getting through to the cockpit that ordinarily would be filtered out for undamaged blades of the set of four, and there is also a significant 2/Rev. The higher frequencies have low amplitudes, and it should be noted that the 4/Rev would be the only frequency transmitted if no damage were present.

From Figure 1, it was found that the 1/Rev is the biggest resultant vibration, and the makeup in Figure 2 shows that the vertical cosine component is the biggest constituent followed by the lateral sine. The longitudinal cosine and vertical sine follow next in absolute amplitude. In a normal undamaged rotor, none of these 1/Rev vibrations would occur for a 4-bladed rotor.

From Figure 1, it is seen that the dominant cockpit vibration comes from 1/Rev, which is the frequency of the main rotor (1×258 rpm) followed by the 2/Rev (2×258 rpm) in amplitude. As the frequency increases, the amplitude of vibration decreases as would be expected except if there is no resonance in the system. A separate study would be needed to determine how these vibrations might fatigue the structure of the aircraft or affect a pilot's ability to fly the aircraft.

Figure 1 shows the cockpit vibration to be above 2 G's for the high-speed condition with half of one blade's outer portion lost. Further performance analysis would be needed to determine the helicopter's residual capability to survive or the pilot's capability to perform. Helicopter first principles can be found in works by Chopra [2], McCormick [3], and Saunders [4].

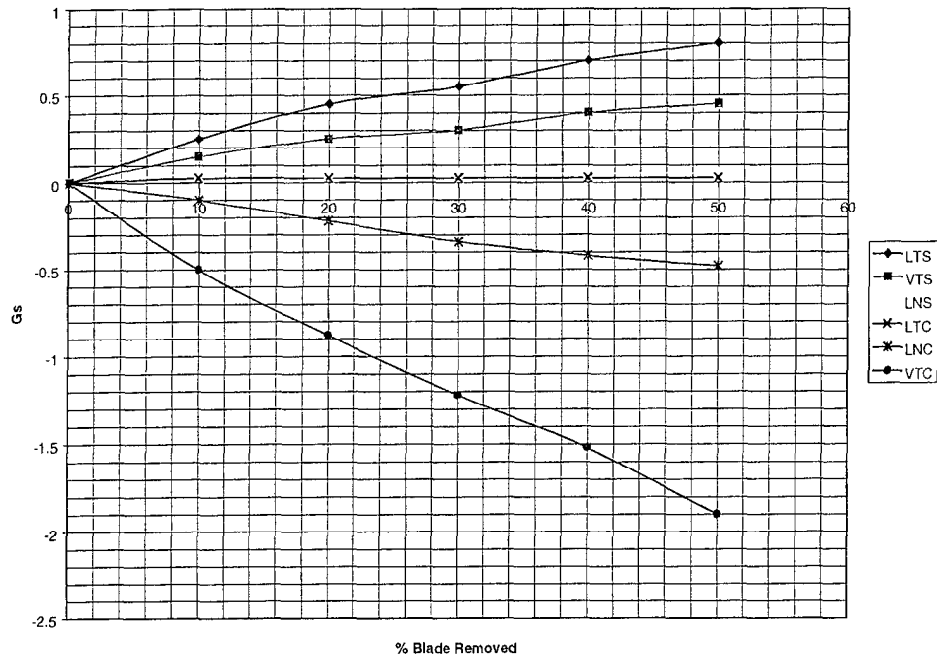
Next, the individual harmonics are viewed one at a time, and the directional cosine and sine components are distinguished. In Figure 2, the legend is defined as follows:

- LNC = Longitudinal Cosine Vibration
- LNS = Longitudinal Sine Vibration
- LTC = Lateral Cosine Vibration
- LTS = Lateral Sine Vibration
- VTC = Vertical Cosine Vibration
- VTS = Vertical Sine Vibration

Figure 2. 1/Rev cockpit constituent vibrations G's vs. percent of blade removed.

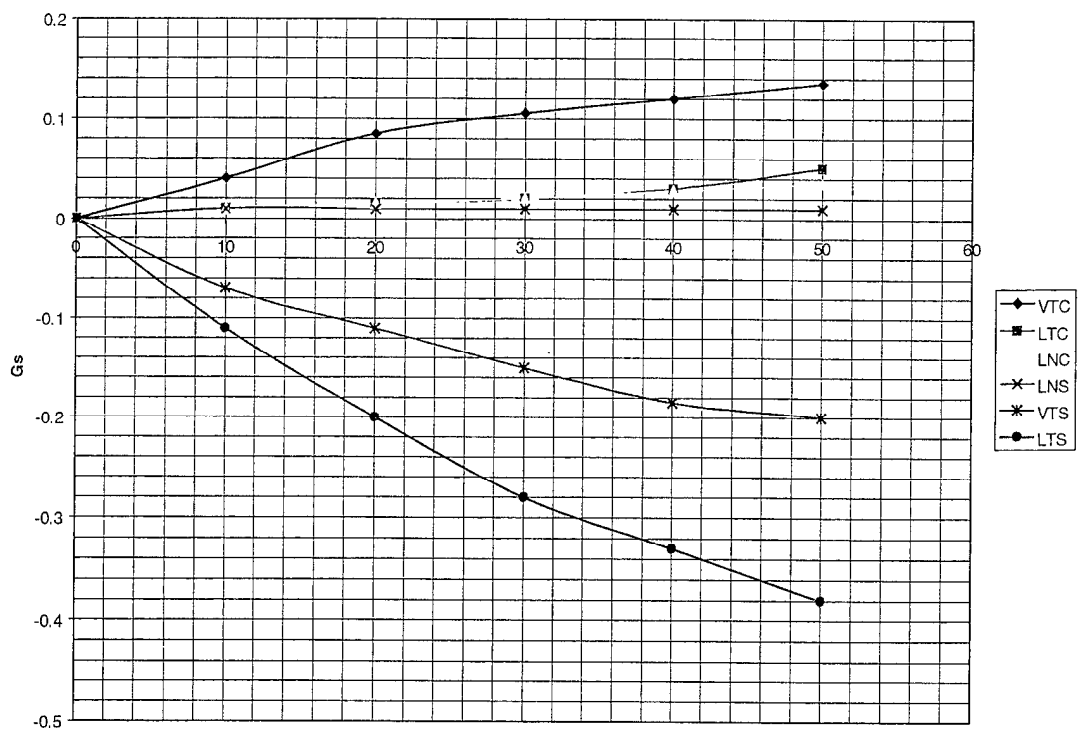
Next in order are the 2/Rev vibrations illustrated in Figure 3. In a normal undamaged rotor, none of these 2/Rev vibrations would occur for a 4-bladed rotor.

Figure 3. 2/Rev cockpit constituent vibrations G's vs. percent of blade removed.

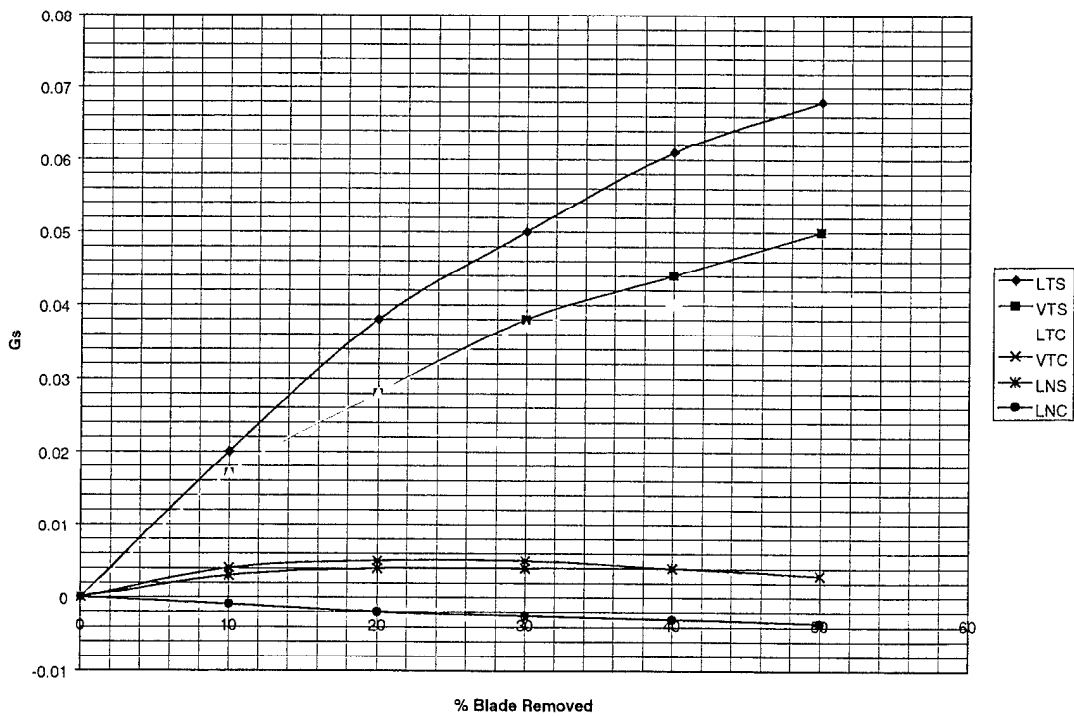
Next are the 3/Rev vibrations illustrated in Figure 4. In a normal undamaged rotor, none of these 3/Rev vibrations would occur for a 4-bladed rotor.

Figure 4. 3/Rev cockpit constituent vibrations G's vs. percent of blade removed.

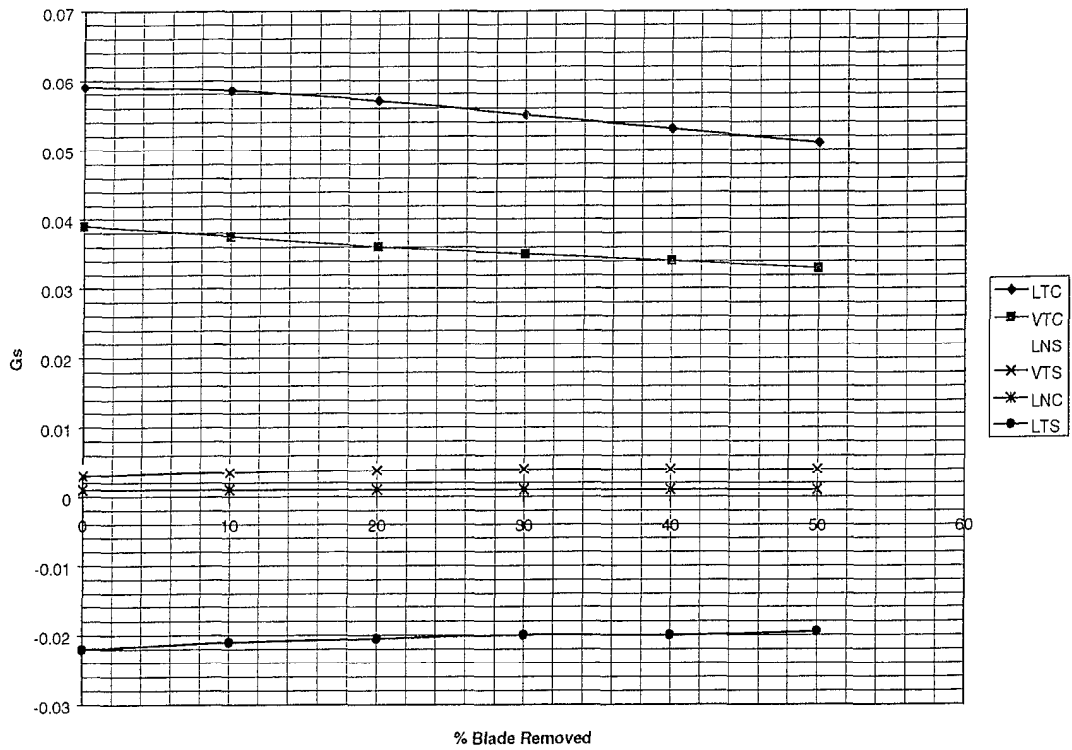
The 4/Rev vibrations are illustrated in Figure 5. Notice that the vibrations for the undamaged blade (at 0% blade removed) are not zero. This is significant and points to the fact that 4/Rev is an integer number of the blades in the rotor and is not filtered out; it is an inherent vibration that always exists. Also notice that the amplitudes of these inherent vibrations are relatively low compared to the 1/Rev that exists when a blade is damaged. These are inherent 4/Rev vibrations that are always present in the cockpit for a 4-bladed rotor.

Figure 5. 4/Rev cockpit constituent vibrations G's vs. percent of blade removed.

As the damage of one blade of the rotor set increases by increasingly more of the outer blade being removed, the vibrations get worse as would be expected. All of the vibrations except the 4/Rev go through the origin of the charts because, in the undamaged state, the frequencies are filtered out and are not transmitted to the fuselage. This is the natural state of the helicopter. The only natural inherent vibration of an undamaged helicopter are the 4/Revs.

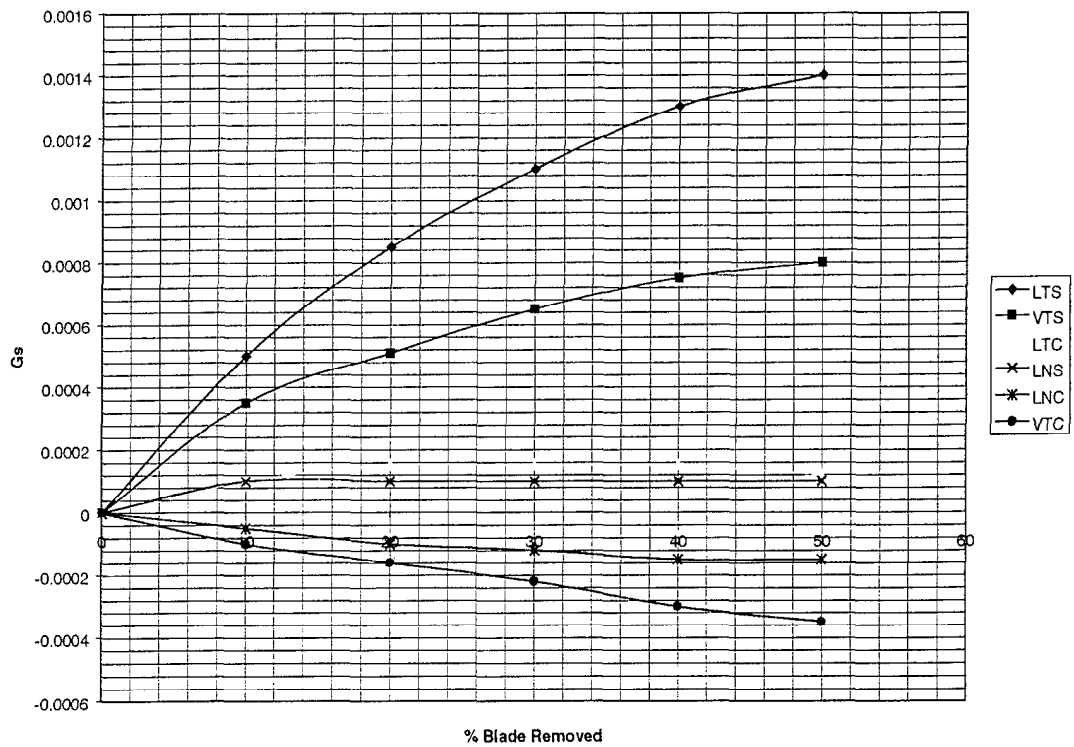
Finally, the 5/Rev vibrations are illustrated in Figure 6. The amplitudes are very small, which is as expected for the higher frequencies. Therefore, there is no need to continue to list the higher frequencies. None of these vibrations would occur for an undamaged 4-bladed rotor.

Figure 6. 5/Rev cockpit constituent vibrations G's vs. percent of blade removed.
